Research Article

Soil-structure interaction analysis of Çelebiğa Mosque, Pertek-Türkiye

Citation: Yıldız, Ö. and Doğan, E. (2022). Soil-structure interaction analysis of Çelebiğa Mosque, Pertek-Türkiye. *Revista de la Construcción. Journal of Construction*, 21(3), 749-766. <https://doi.org/10.7764/RDLC.21.3.749>.

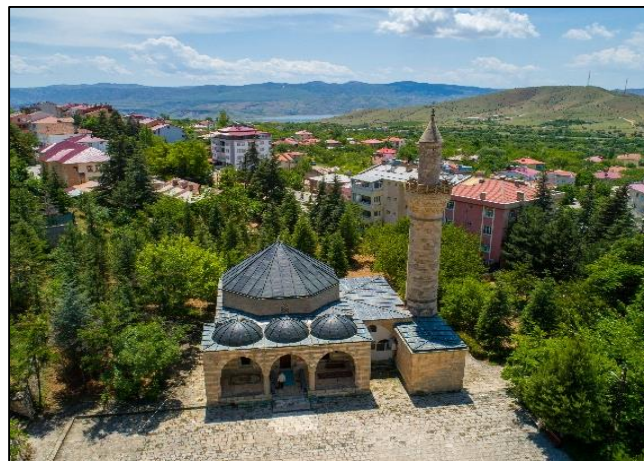
Figure 2. View of the Çelebiaga Mosque in the transferred location.

Çelebiğa Mosque was built on the foothills of Pertek Castle in 1570, with the imaret, madrasah, cemetery, and fountain adjacent to the building, where it is first located (Figure 1) (Danık, 2004). After the relocation decision of the mosque, it was reconstructed on a sloping land descending from north to south, at the exit of the Elazığ highway of Pertek District. (Figure 2). Within the context of fieldwork, simple surveying drawings of the building were obtained by taking the necessary measurements to understand the geometry of the building (Figure 3). In the building, there is a square-planned big prayer hall (harim), which is entered by passing the three-section narthex with a short side of 3.80 m and a long side of 12.90 m, located on the northern axis. The outer part of the big prayer hall is 11.20 m x 11.20 m long, and the interior is 9.10 m x 9.10 m long. The big prayer hall is surrounded by masonry stone walls with a thickness of approximately 1.00 m, and a height of 5.50 m when measured indoors. The big prayer hall is covered by a dome with a diameter of 8.15 m and a height of 9.50 m from the ground when measured from the interior, which is supported by masonry stone walls and placed on an octagonal high pulley. In the big prayer hall, passes to the dome are provided with squinches. In the west of the big prayer hall, there is a rectangular planned second prayer hall covered with a barrel vault. On the west wall of the second prayer hall, there is a minaret at 24.75 m above the ground and a fountain adjacent to the minaret.

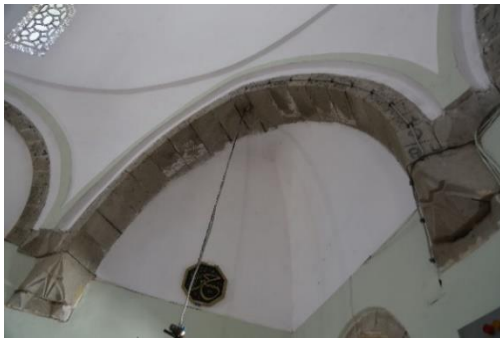
Figure 4. Deficiencies in the joint filling of the arch elements in the interior.

Various maintenance and repair works were carried out in different periods between the years of 1977 and 1988, to solve the structural damages in the Çelebiaga Mosque that emerge after the relocation process. Within the context of the study, the existence of some structural problems in present conditions was determined during the observational and technical visits to the area. In a significant part of the arch elements in the interior, deficiencies in the joint filling were determined (Figure 4). Humidity/insulation problems, which are thought to be caused by the roof covering, were confronted in the dome elements. Brittle fractures up to 2 cm in width were determined from place to place, especially in the junction areas of the windows in the dome (Figure 5). The stones used at the masonry walls in the interior were broken/spilled partly (Figure 6). Significant implementation defects were detected at the stone joints in the interior (Figure 7). On the stone elements in the exterior walls of the building, hollows, fractures, and spills were observed (Figure 8). Insulation/humidity problems and color changes were determined in the parts of the exterior walls of the building close to the ground (Figure 9).

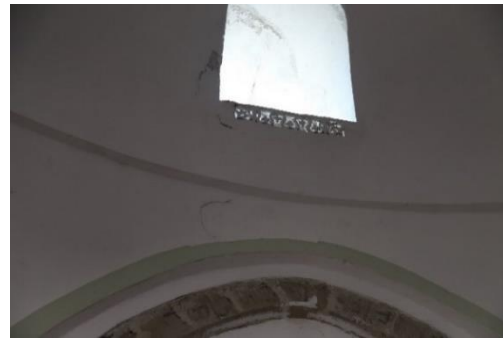
Figure 5. Humidity/insulation problem of the windows in the dome.

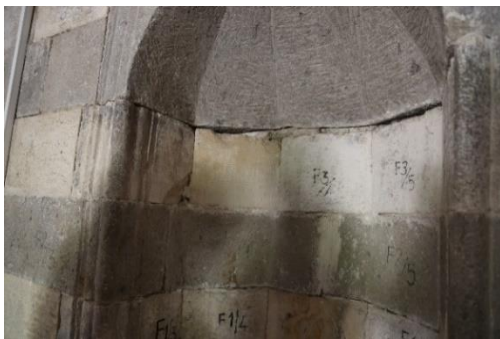
Figure 6. A sample of broken/spilled stones in the interior wall.

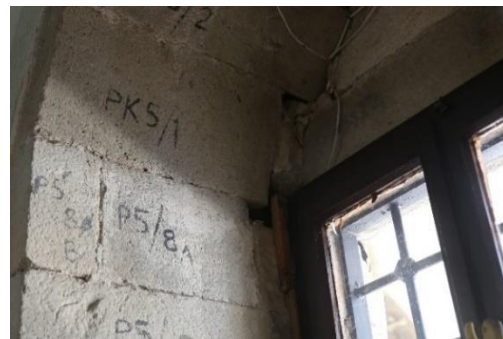
Figure 7. One of implementation defects at the stone joints in the interior.

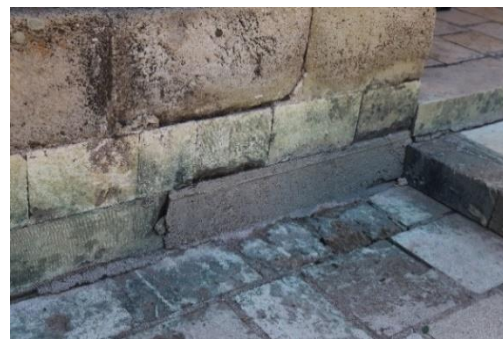
Figure 9. A sample for Insulation/humidity problems of exterior walls.
