# *Ecuadorian asphalt aging in laboratory and field. Relationships and analysis*

## El envejecimiento del asfalto ecuatoriano en laboratorio y obra. Relaciones y análisis

Rolando Vila Romani <sup>\*1</sup> <https://orcid.org/0000-0002-9109-5679>; Walter Antonio Mera Intriago\* <https://orcid.org/0009-0005-0765-448>;  
Lorena García Cucalón \*\* <https://orcid.org/0000-0003-3139-1457>

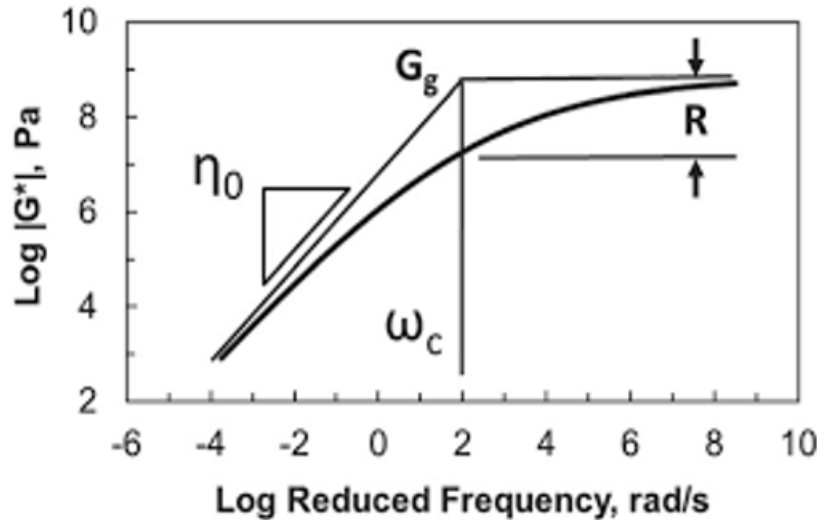
Figure 2. Typical master curve parameters (Christensen et al., 2017).

Studies were also carried out with DSR equipment to determine the master curves of aged asphalt, according to the Christensen-Anderson model (Christensen et al., 2017), using frequency sweeps between 0.1 Hz and 37.5 Hz, varying temperatures between 10°C and 70°C with 10°C increments. (Figure 2) shows a visual representation of the main parameters of these curves.

The glassy modulus ( $G_g$ ) is the largest complex modulus  $|G^*|$  reached at extremely high frequencies or very low temperatures. In general, it is assumed as a constant value of 109 Pa for all binders. Low shear rate-limited viscosity,  $\eta_0$ , is another characteristic often used to describe the high temperature-low frequency asymptote of the master curve. The crossover frequency ( $\omega_c$ ) corresponds to the frequency where the phase angle ( $\delta$ ) is 45°, that is, where the elastic component of the complex modulus ( $G'$ ) is equal to the viscous component ( $G''$ ). For most binders,  $\omega_c$  is almost equal to the intersection of  $G_g$  (purely elastic) and  $\eta_0$  (Newtonian or purely viscous flow) at a particular reference temperature ( $T_0$ ). The crossover modulus ( $G_c$ ) corresponds to the value of  $|G^*|$  in  $\omega_c$ , and the rheological index (R-Value) is the difference between the logarithmic values of  $G_g$  and  $G_c$ . With aging, for a  $T_0$ , the R-Value increases,  $\omega_c$  decreases, and  $G_c$  decreases (Anderson et al., 1994).

The viscoelastic transition temperature ( $T_i$ ), also called the crossing temperature or melting point, is another of the parameters considered to assess aging. It corresponds to the temperature of the asphalt in which the elastic and viscous components of  $|G^*|$  are equal, that is, where its phase angle ( $\delta$ ) is 45° using a constant test frequency. It can be assumed that the transition point from solid to fluid shifts as molecular motion is hindered with aging, so more energy (increased temperature) will be required to generate the flow. The performance of binders that remain below the warning threshold of 32°C after 20 h PAV aging, and below the limit of 45°C after 40 h PAV aging is considered satisfactory, using a frequency of 10 rad/s (García Cúcalón et al., 2019). The criteria correspond to the temperature range of the US state of Virginia.

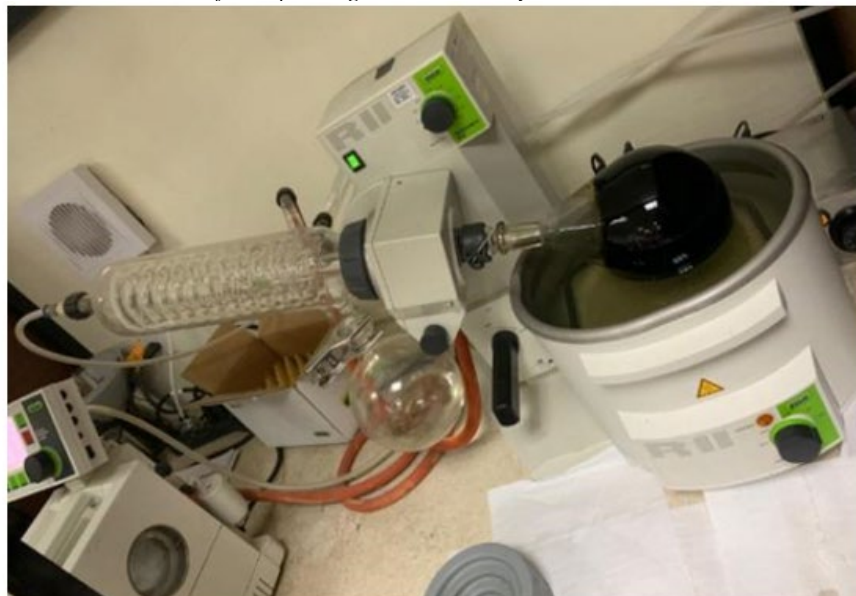
**Figure 3.** Rotary evaporator equipment used.

*In the cores, the aged asphalt of the most superficial layer was recovered in a thickness of 12 mm, using the procedures indicated in the ASTM D2172/D2172M-11 and ASTM D5404/D5404M-12 standards. See (Figure 3). Dichloromethane was used as a solvent. The properties evaluated were the same as those of the asphalts aged in the laboratory.*

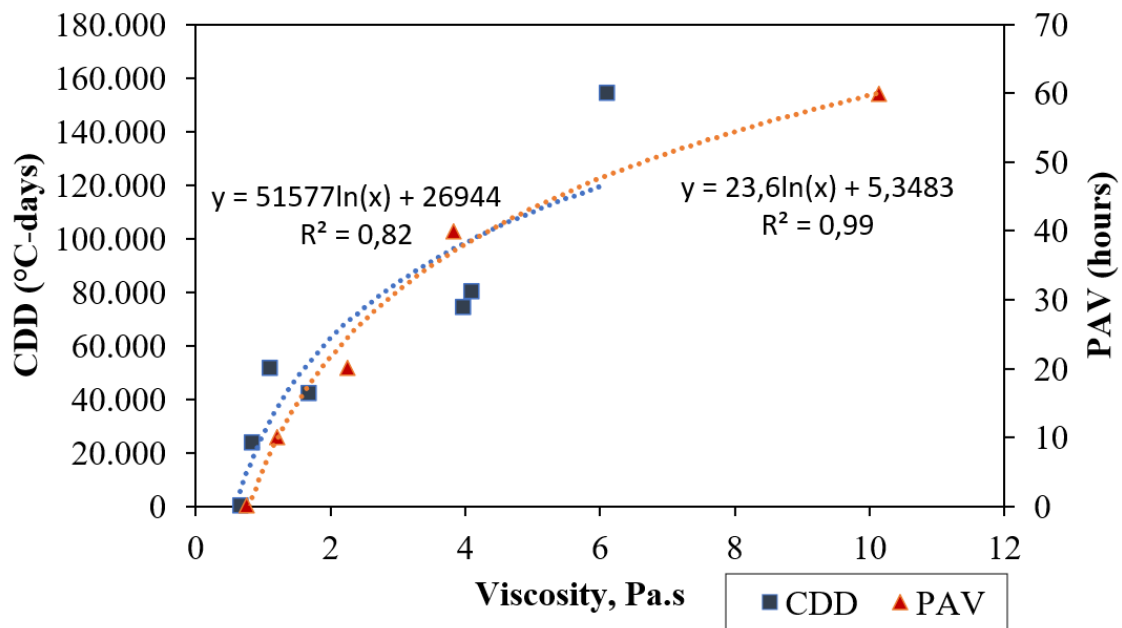
**Figure 4.** Viscosity variations for laboratory and field aged asphalts

(Figure 4), (Figure 5), (Figure 6), (Figure 7) and (Figure 8) show the relationships between the results of each rheological parameter, taken from (Table 3) and (Table 4).

In general, the results show a significant increase in the rheological parameters evaluated with aging, except for frequency, where it decreases. These results confirm the expected behavior. In figures 4 to 8, the R2 determination coefficients showed better correlation between the tests carried out in the laboratory, than the recovered asphalt on site. These coefficients varied between 0.82 and 0.99 but were mostly above 0.90.

From the equations shown in (Figure 4), (Figure 5), (Figure 6), (Figure 7) y (Figure 8), the values of the rheological parameters were calculated for the PAV of 0, 10, 20, 30, 40, 50 and 60 hours, and with these values the corresponding CDD. The results obtained were graphed in (Figure 9), which shows the well-established linear relationship between PAV and CDD, with a high R2 value.

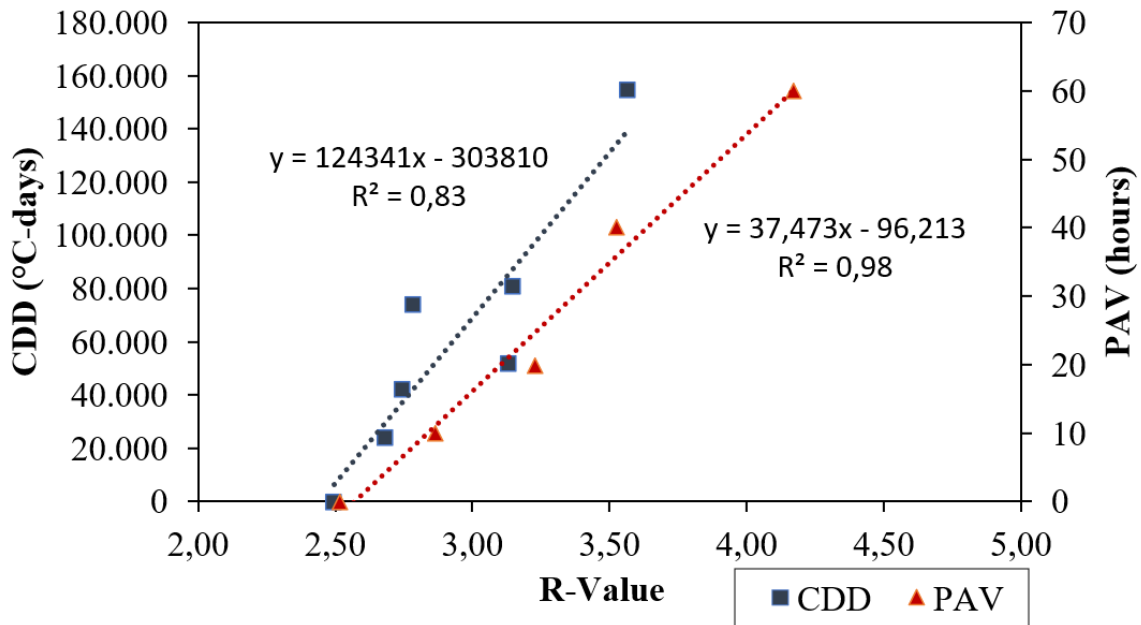
Figure 5. R-Value variations for laboratory and field aged asphalts

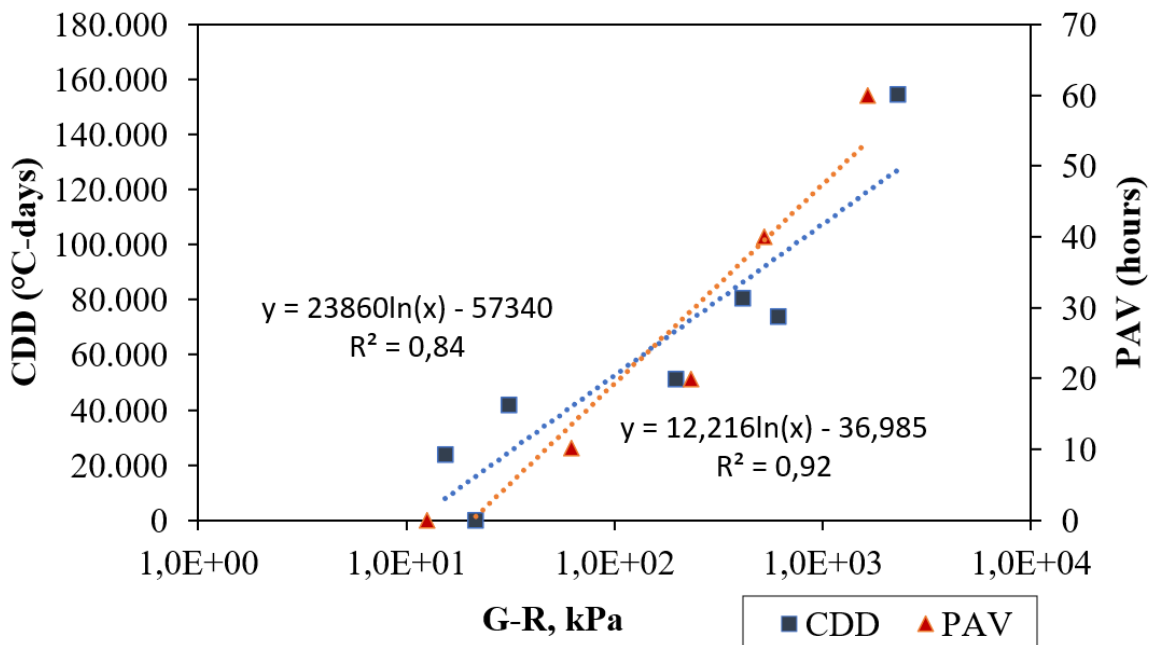
Figure 8. Glover-Rowe parameter variations for laboratory and field aged asphalts

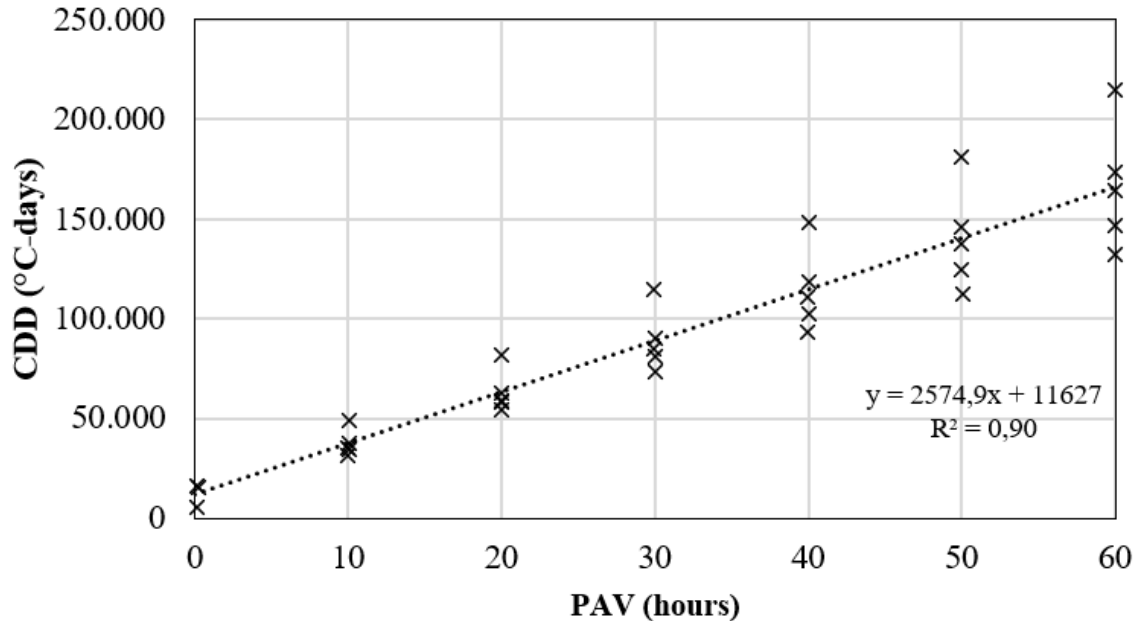
Figura 9. Variation of CDD versus hours in PAV.

With the relationship shown in (Figure 9), two significant aspects related to the quality of our asphalt were checked: the CDD corresponding to the PAV equal to 0 hours (only RTFOT) and to the PAV of 20 hours (usually used). With the CDD, the estimated service time in months for the regions was subsequently calculated, according to the (Equation 2) and (Equation 3) obtained in previous studies (Vila et al., 2022). (Table 5) shows the results obtained.
