Analysis of seismic design criteria of Santo Domingo Church, a Colonial Heritage of Santiago, Chile

Natalia Jorquera (Main and Corresponding Author)

Abstract

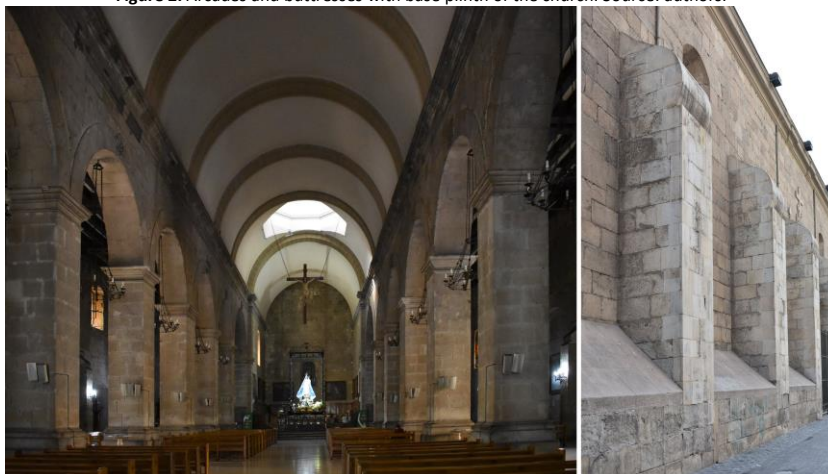
Figure 2. Arcades and buttresses with base plinth of the church. Source: authors.

The longitudinal walls have external and internal stone buttresses (Figure 2) of 1.1 m x 1.3 m in plan and 8.3 m high (they are lower than the perimeter wall), which prevent out-of-plane flexing of the walls during seismic thrusts.

A base plinth is present along all longitudinal walls, which help lower the center of gravity and reduce the height of the walls subjected to out-of-plane mechanism (Figure 2).

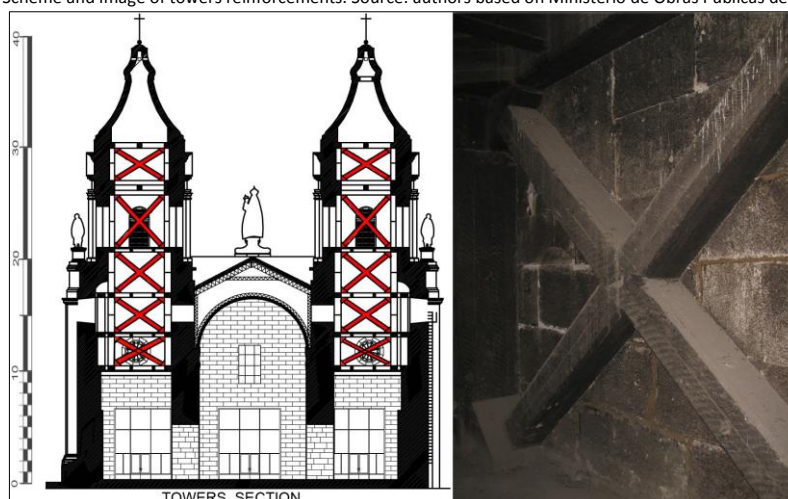
Figure 3. Scheme and image of towers reinforcements. Source: authors based on Ministerio de Obras Públicas de Chile plans.

Concrete reinforcement of the towers starts at 9.6 m high, in the same position as the old choir. The reinforcement consists of beams, pillars and diagonals, semi embedded into the brick walls by their interior face, so they are not visible (Figure 3).
